## IMPLEMENTATION – POST-TRIP REPORT

## 1. Project Description

This section discusses the situation in the community and findings from the 2017 assessment trip that led to the development of the project. Maras experiences a severe water shortage, and one of the areas greatly affected in the community was the local elementary school. The school was only receiving one source of water due to a failure in their other water system. The following is an excerpt from this detailing the issue:

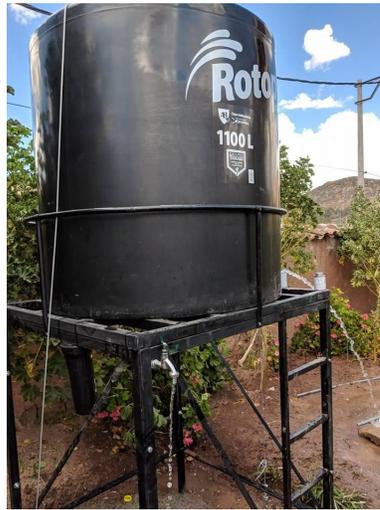
*Photo 1: The completed tank and stand structure*

*Upon our arrival at the school, our team set out to complete the foundation for the aboveground water storage tank. This task was performed by Tomas Moffatt, Kelly Napoli, Noah Esham, and Dennis Hornsby (hereby referred to as the "construction team") and a few parents of children at the school, who volunteered to assist. A large 5'9" x 5'9" x 6" square hole was dug into the school's garden area (picture below). Then, in each of the four corners of this square hole, 2' x 2' x 1' holes were dug. All holes were measured with a 4 foot level. The construction team and volunteer parents then mixed concrete to be poured into the holes to serve as the foundation for the aboveground water storage tank steel base to be placed on.*

*The concrete was allowed to set overnight, and then the construction team assembled the steel base for the aboveground water storage tank and placed it atop the concrete*

*foundation. More concrete was then mixed and poured around the legs of the steel base so that the base would be affixed in place. The Rotoplas basin was then placed on top of the steel base and secured in place by the construction team.*

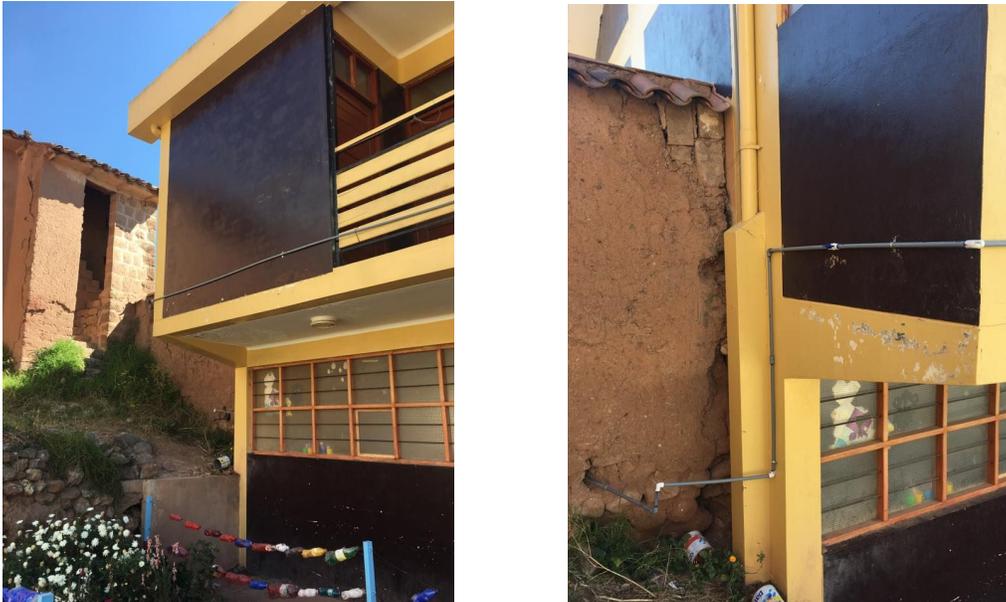
Photo 2: Various pictures of the routing of the pipe along the exterior walls of the school (this pipe connects the secondary water supply to the aboveground water storage tank)

*Work then began on plumbing the secondary water source to the aboveground water storage tank. Using PVC pipe and PVC fittings, the construction team tapped into the secondary water supply and routed piping along the exterior walls of the school to the new aboveground water storage tank. The piping was then connected to the tank, and a faucet and water filter were placed on the outlet of the tank so that it could be used to supply clean water to the school.*

*Many of the school's walls differ in their material composition. This meant that we needed to experiment with different fasteners for attaching the pipe clamps for different walls in the school. Some of the clamps were attached to wooden beams, for these walls we used self-drilling wood screws. Other walls of the school were made of a thin layer of plaster*

*covering solid concrete. For these walls we decided to use a concrete drill bit to predrill the wall, then insert a concrete nail anchor into the drilled hole, and then use a concrete nail to attach the pipe clamp to the wall.*

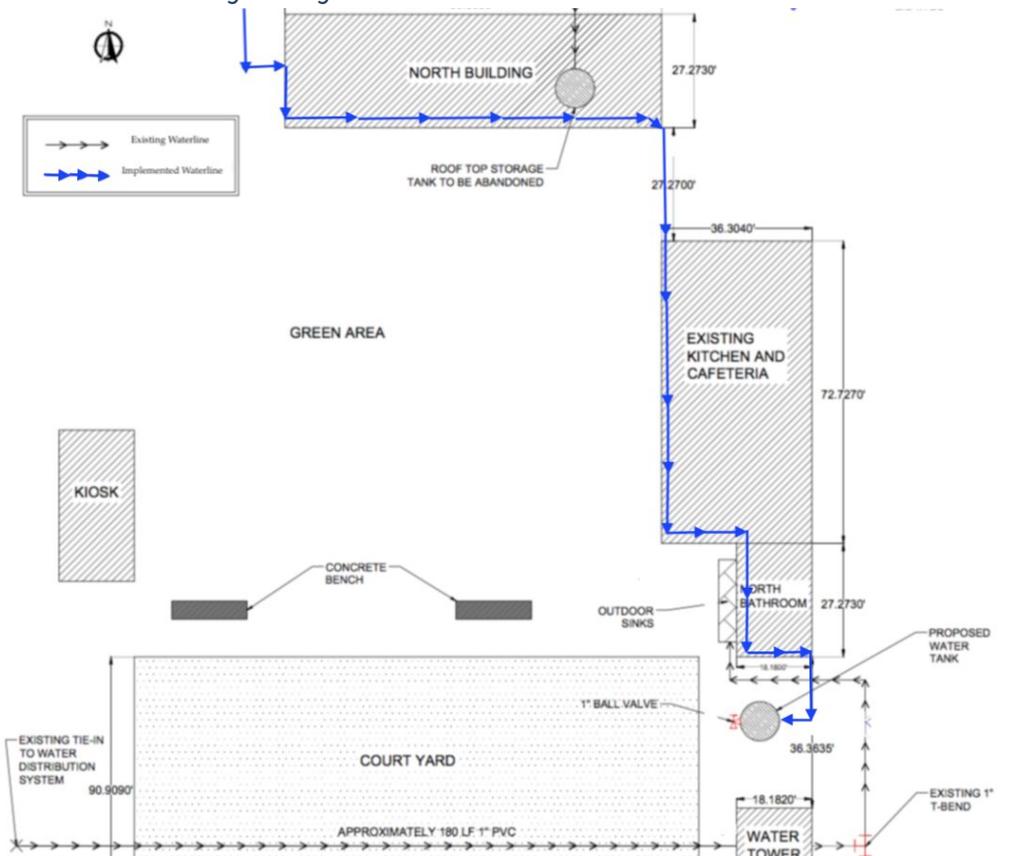
**A-1:** Above-ground 1/2" PVC route from secondary water source (NW corner) to the above-ground 1100L water storage tank

*There were a few changes from the planned construction. Upon surveying the site again, the team realized that if the pipe was underground as previously planned, there was a concrete sidewalk that would need to be removed and replaced, as well as making the pipe harder to service if any issues arise. The team decided that the pipe could be run along the walls of the school instead. This would avoid busting up the concrete and make the pipe visible for the whole route, making it easier to service. The other change from the initial proposal was the team decided not to run a pipe from the aboveground storage tank to the underground storage tank. This decision was done in order to avoid conflict with the current electric pump already in place within the water tower which takes water from the underground water storage tank to the elevated water storage tank. The team did set up the tank so that it can be easily connected as previously proposed, if the community decides to do so.*

*When plumbing the secondary water supply to the new aboveground water storage tank, the quantity of the PVC pipe and couplers changed. Upon arriving at the community, the team decided to modify the original design to run the pipe at an elevated location along the outside of the school building instead of trenching it through the school's courtyard. Because of this additional couplers were necessary to route the pipe around the existing corners of the school building. The quantities of PVC cement and teflon tape were increased as well because of the increase in quantity of PVC couplers, which are held together by either the PVC cement or the teflon tape. The quantity of stainless steel pipe clamps increased because the elevated pipe run along the school building required the attachment of the pipe to the walls of the school buildings, this called for additional stainless steel pipe clamps.*
